Surveying errors within the Great Pyramid of Giza

The Great Pyramid papers

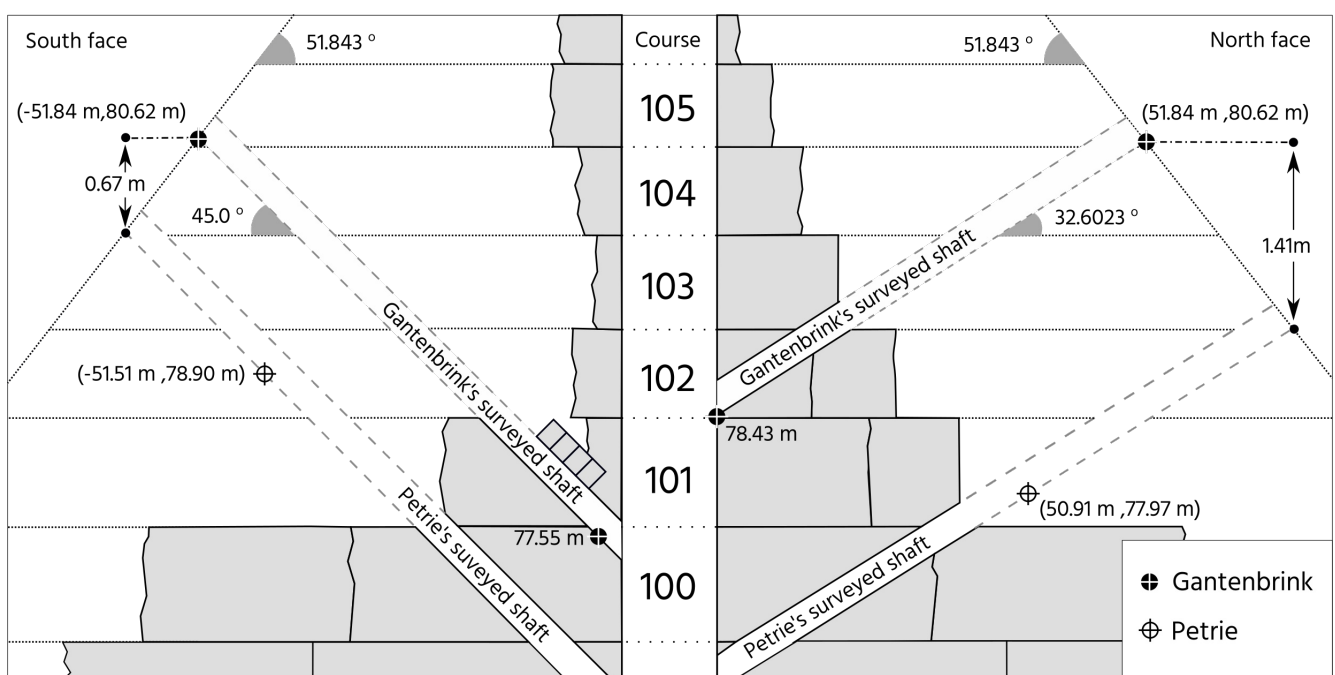
Diagram A1 - The exits of the Great Pyramid's upper shafts

Diagram A1 shows the shaft exit points on either side of the pyramid, Petrie's station marks, Gantenbrink's surveyed shaft positions, their intersect with the pyramid's faces and his shaft exit heights from the body of his text⁴. To verify the course levels of the shafts exits, HD video footage from a drone flight over the Great Pyramid⁵ and photography taken from the ground was studied, and it was confirmed that the shafts exit on the 101st level of the current core masonry on both the north and south side of the pyramid. Diagram A1 is therefore a verified technical drawing of the combined surveying data of Gantenbrink and Petrie.

The surveyed shaft positions do not correspond with each other, with a vertical discrepancy of 0.67 m on the south side and 1.41 m on the north side. Also, Gantenbrink's spot heights for the shaft exit points of 77.55 m on the south and 78.43 m on the north are both located inside the pyramid's existing masonry, and Petrie's survey points are located outside the existing masonry.

Because Petrie's surveying of the internal features of the pyramid is known to be accurate and there is no reason to doubt Gantenbrink's modern digital measurements, it was concluded that there must be an error in the positioning of the internal architecture of the building onto which Gantenbrink has attached his shaft survey data.

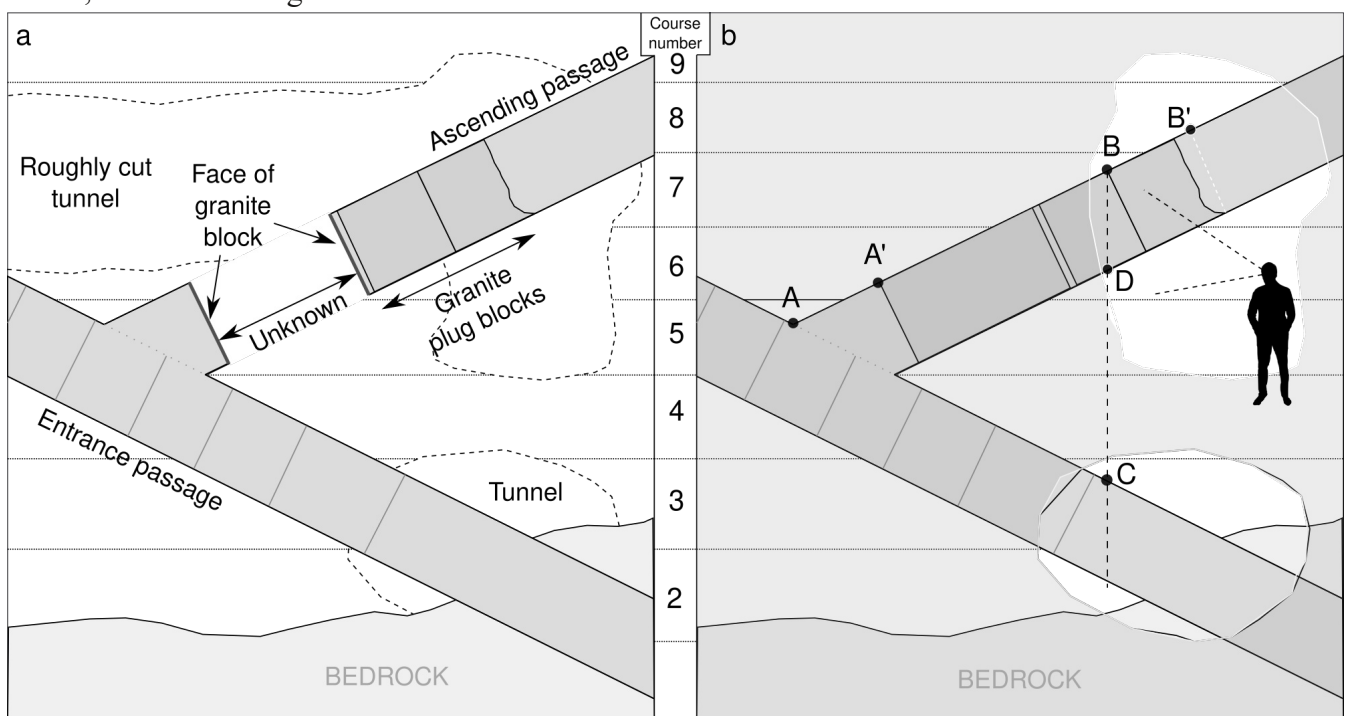
Diagram A2 - The ascending passage a) Cross section looking east b) View from inside the roughly cut tunnel

Diagram A2a shows our current understanding of the ascending passage. The entrance passage descends into the bedrock of the Giza plateau, and in its roof there is the start of a passage which is blocked by a granite stone, only the face of which is visible. Diagram A2b shows a roughly cut tunnel, known as Al-Mamun's tunnel, that leads from the outside of the pyramid and which emerges in two places, the first is in front of the two granite plug blocks, and the second is in the entrance passage, with a 4 m deep, nearly vertical, hole connecting the two sections.

In order to connect the external and internal surveying of the pyramid, it is necessary to determine the length of the unknown section of passage, and this task was performed by Smyth⁶, and his explanatory diagram is replicated in diagram A2b. Point B is the top of the joint between the first and second plug blocks at the passage roof level, from which Smyth dropped a short plumb line. Point D is a point on the end of a long rod which Smyth visually aligned with the short plumb line and which is at least 1.2 m in front of the plug block face, from which he dropped a second long plumb line. This procedure was necessary because there is masonry directly below the floor of the passage under point B prohibiting a plumb line being dropped more than the height of the ascending passage, and below point D this is no longer the case. Point C is a point in the entrance passage which is the bottom of the long plumb line that was dropped from point D, and that is vertically coincidental with points B and D. Point A is the intersection of the roofs of the entrance and ascending passages, and point A' is the ascending passage roof at the face of the granite stone.

At the time of performing his calculation, it was thought that the entrance and ascending passages were of equal and opposite angle, which they very nearly are, and so Smyth's logic was as follows. The distance AC must be the same as the distance AB and therefore the length of the hidden section of passage plus the second plug block, the length A'B, can be calculated because both AC and AA' can be measured in situ. By carrying out this calculation Smyth determined that the distance from point A' to the top face of the upper block point B' was 178.8 inches, or 4.542 m. This value was then used without question by Petrie, and continues to be the basis of all current drawings and models of the pyramids, including Gantenbrink's.

Smyth's analysis is flawed because he has started with the assumption that the granite block face that is visible in the entrance passage roof and the plug blocks that are visible in the ascending passage are a linear continuation of each other. Although this would appear to be a sensible proposition, there is no evidence to support this assumption, and therefore Smyth's determination of the length across the hidden section of the passage is a meaningless value. Moreover, the ascending passage could be placed anywhere in 3D space relative to the apparent start of the ascending passage in the entrance passage roof.

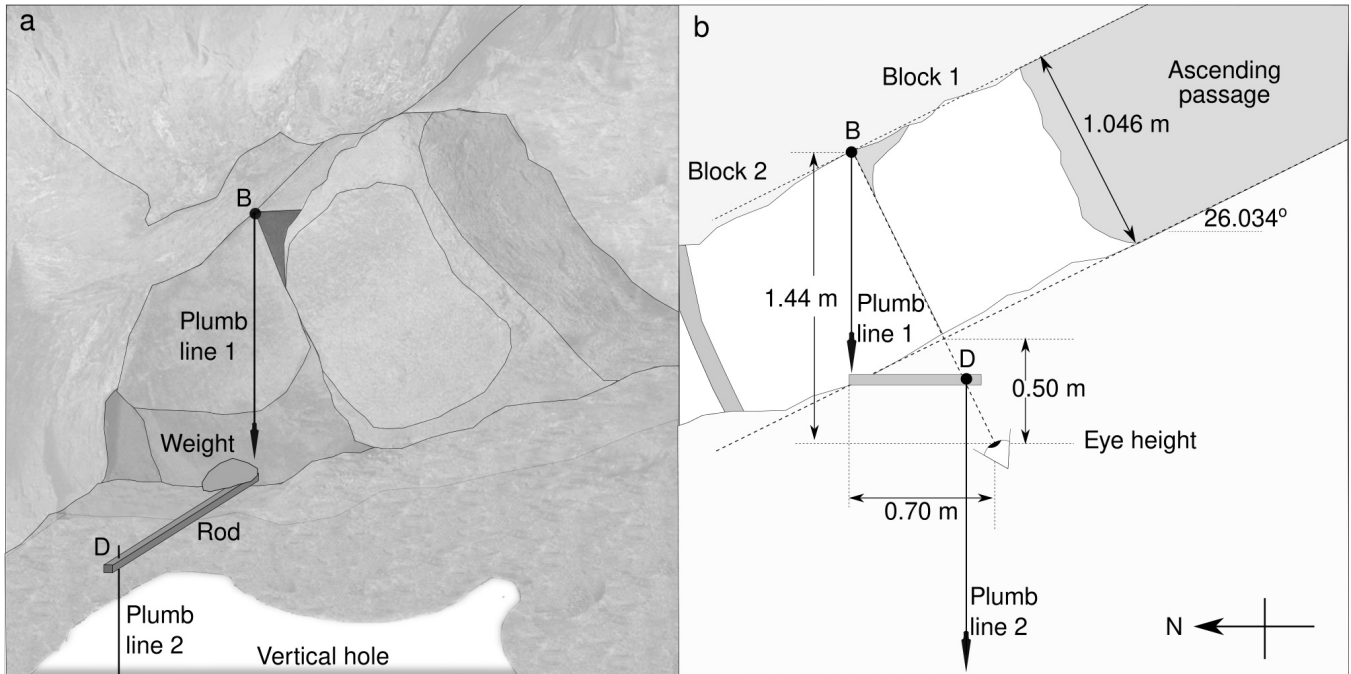
Diagram A3 - An analysis of the surveying error of Smyth

Diagram A3a is an illustration of the method that Smyth used to project his vertical line from the top of the joint between the two plug blocks into the entrance passage below, the points B and D being the same as those shown in Diagram A2. He aligned these points visually using the only reference plane available in the rough tunnel, that being the upper face of the second plug block, which is in pristine condition and is exposed due to damage to the back face of the first plug block.

Standing at the near (west) side of the vertical hole in the floor which descends to the entrance passage, Smyth has aligned himself with the front face of the second plug block by slightly adjusting his standing position from right to left until the block's face just disappears from view. Assuming at that point that he is in line with the joint between the two plug blocks, he has then adjusted the position of the rod onto which the long plumb line is attached so that this plumb line is vertically in line with the short plumb line which is hanging from point B. He has then descended into the entrance passage and marked off the position of the long plumb line in that passage.

The error that he made is shown in figure 3b. When visually aligning himself with the front face of the second plug block he has not taken into account that the plane of the plug block's face, combined with his eye height, will have caused him to be offset to the right of the point B.

Smyth's eye height can be determined because he had a photograph⁷ of himself taken outside the pyramid whilst holding one of his surveying poles vertically, as a prop, and the major measurement divisions on the surveying pole are visible from which Smyth's height can be estimated as being 1.75m. Standing just in front of the vertical hole in the floor, my eye height was measured against the lower part of the plug block joint as being 0.37 m below it, and so Smyth's eye height must therefore have been about 0.50 m below the same point when making his alignment, as shown on the illustration. By trigonometry, this has resulted in him being 0.70 m to the right (north) of the point B and the long plumb line start point D, which would have been just in-front of him, approximately 0.60 m offset. As there is currently a concrete floor in this section of the tunnel upon which I was standing when taking the measurements, which increases the Smyth's error value, all surveying measurements of the internal architecture of the building must be offset by somewhat more than 0.60 m to the south.

With the angle of the ascending passage being known, this horizontal error of 0.60 m to the south would produce a corresponding vertical error of 0.29 m, which corresponds to the vertical error of 0.29 m that was measured when connecting the inside and outside of the building's surveying.

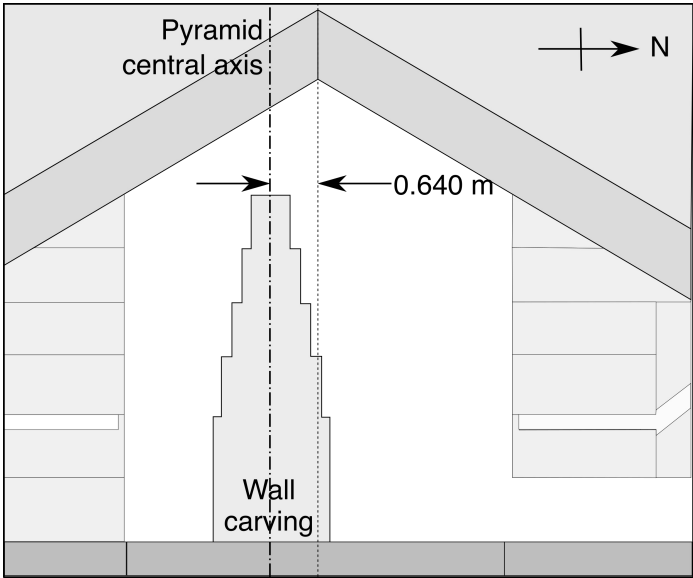
Diagram A4 - The lower chamber with the correction applied

A more precise value for Smyth's horizontal error was determined by looking at other parts of the building's architecture which are known to relate to the position of the central vertical axis of the building. Diagram A4 shows the lower chamber of the pyramid.

The apex of the lower chamber roof was surveyed by Petrie as being in line with Smyth's incorrect central vertical axis of the pyramid, and the central axis of the symmetrical wall carving in that chamber was surveyed at 0.64 m to the south of the roof apex. If this value is taken as being the accurate value for Smyth's horizontal surveying error, then the wall carving becomes positioned on the central axis of the pyramid

By relating the surveyed value of the carving's central axis offset against the room's vertical axis to the known angle of the ascending passage, the transformation required to correct the surveying of the internal architecture of the building was calculated as :

North: 0.64 m
Vertical: -0.313 m

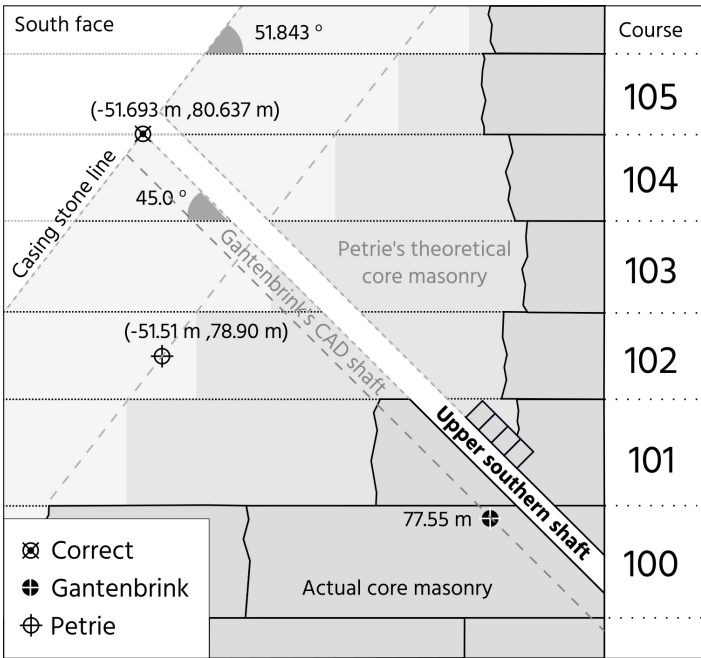
Diagram A5 - The upper southern shaft exit

The upper southern shaft's surveying by Gantenbrink is continuous from the upper chamber to the outlet on the face of the pyramid and the result of applying the correction to the internal surveying is shown in Diagram A5. When the shaft is moved down by 0.313 m and to the north by 0.64 m it ends up with the floor of the shaft aligned to the roof of Gantenbrink's original shaft position. With the accuracy of Gantenbrink's surveying not being in question, the discrepancy shown at the outset of this work between the two sets of survey data on the south side of the building was determined as being in Petrie's station mark placement.

exit points to reference points on the ground, and the horizontal component of his station marks must therefore be a calculated value against the angle of the pyramid's face angle. Upon studying photography⁵ of the exit points and Gantenbrink's images⁹ it was seen that the southern shaft exit point is inset over 3.0 m relative to the core masonry plane, which corresponds to the CAD drawing with the internal architecture correction applied. Petrie's station mark placement falls on the line of the theoretical core masonry and it was concluded that this point is incorrectly placed.

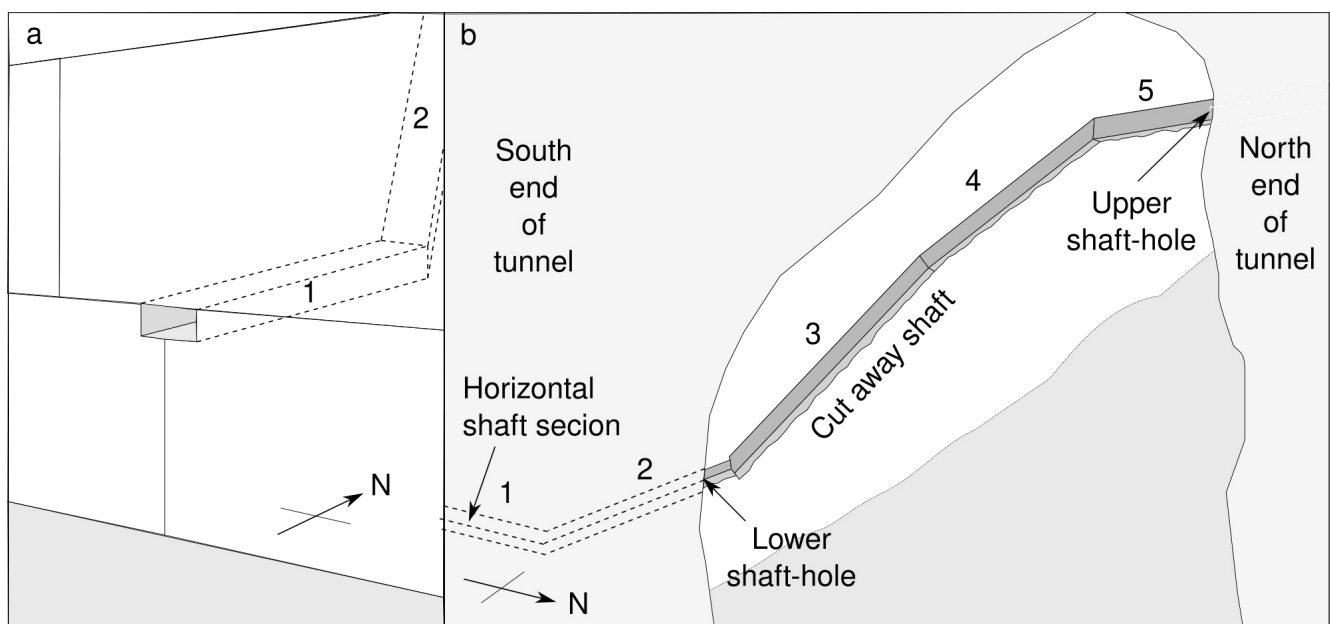
Diagram A6 - a) North wall of the upper chamber b) The tunnel at the back of the upper chamber north wall

Diagram A6 shows our current understanding of the lower sections of this shaft with Diagram A6a showing the shaft's starting point in the north wall of the upper chamber, and Diagram A6b showing the tunneled out section directly behind that north wall. These sections of the shaft are made up from 5 blocks of stone, which are numbered in the illustrations.

When Gantenbrink surveyed this shaft he did so in the following manner. First, he manually measured the horizontal section of shaft stone from inside the main chamber, and determined that it was 2.63 m long. Second, he went into the tunnel area behind the north wall and surveyed all of the cut away stones' lengths and angles using manual surveying equipment. Third, he placed his robotic inclinometer device inside the upper shaft-hole in the tunnel and attached it to a cable which had previously been lowered into the shaft from the shaft's exit on the northern face. From outside the pyramid he dragged the inclinometer device up the shaft by pulling on the cable, measuring the distance traveled and the inclinometer angle at numerous points within the shaft. These three sets of data were then joined together to form the basis of his technical drawings.

There is no scientific evidence that the first two blocks of stone seen when looking inside the shaft from the main chamber are the same as the first two blocks of stone that can be seen when looking into the lower shaft-hole in the tunneled out cavity behind the north wall. The assumption that they are the same is clearly entirely logical, but not a proven fact because there is no record of anyone ever having inserted an object into the shaft in the main chamber and then later recovering that same object via the lower shaft hole in the tunnel, or visa-versa.

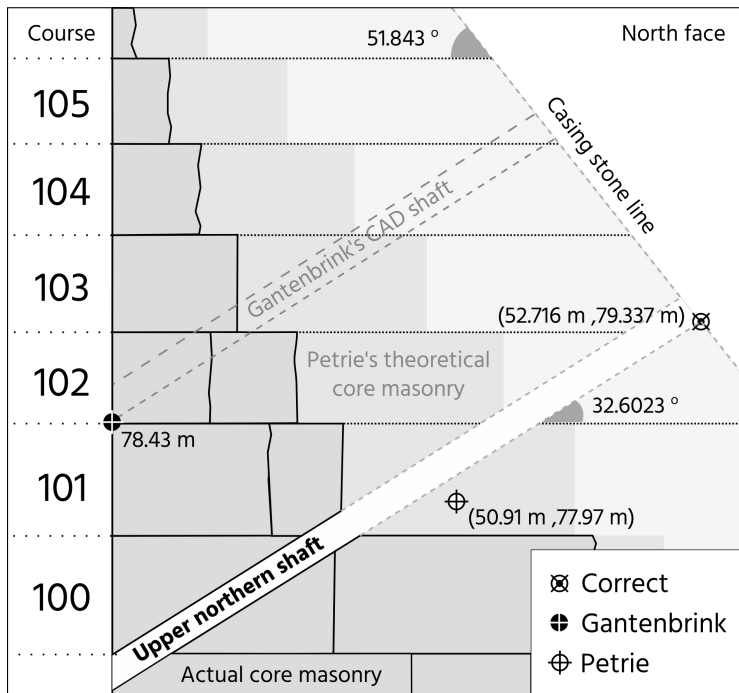
Diagram A7 - The upper northern shaft exit

Gantenbrink's technical drawings show the termination point of the upper outlet of the shaft on the pyramid's northern face precisely, with the top of the 100th level of masonry clearly indicated. To connect the shaft to the external surveying of the pyramid rather than the internal surveying, the upper northern shaft survey data was re-positioned on the CAD drawing, aligning Gantenbrink's shaft exit level with the level of the exit determined from the photography analysis, the result of which is shown in Diagram A7.

With the technical drawing of the shaft now correctly positioned in relation to the external surveying data, and knowing that the accuracy of the measurements within it were not in question with a tolerance of a few centimeters linearly and 0.2 degrees angularly, the start of the shaft was resolved.

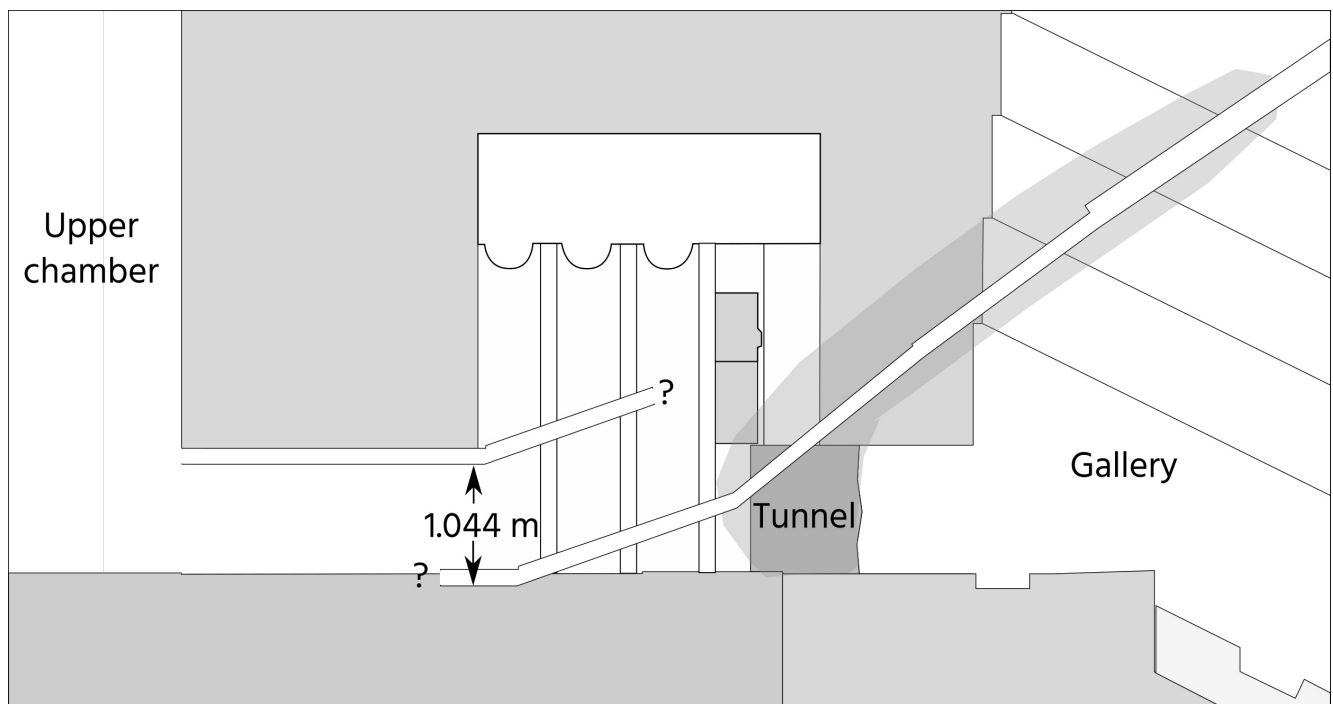
Diagram A8 - The upper chamber northern shaft and the upper northern shaft end inside the tunnel

The result of attaching the shaft survey data to the outside of the pyramid is shown in figure 8. At the lower end of the shaft the floor of the horizontal section of the shaft that is visible from inside the tunnel is 1.04 m above the surveyed shaft's horizontal floor, a distance that corresponds to the surveying error between Gantenbrink's CAD drawing and the actual shaft exit level on the northern face of the pyramid.

The lower northern shaft that starts in the main chamber and the shaft section that is visible on the south side of the tunnel behind the upper chamber's north wall are two distinct features. Therefore they are two sections of the pyramid's architecture which have never been explored beyond their respective bend points, as shown by the question marks in Diagram A8.

It is also shown that the upper northern shaft which starts in the main chamber is not the same shaft as the one located at the south end of the antechamber tunnel behind the main chamber's north wall.
